Belleville Train Depot

Historic Structures Report & Study

November 25, 2015

Destree Design Architects, Inc.

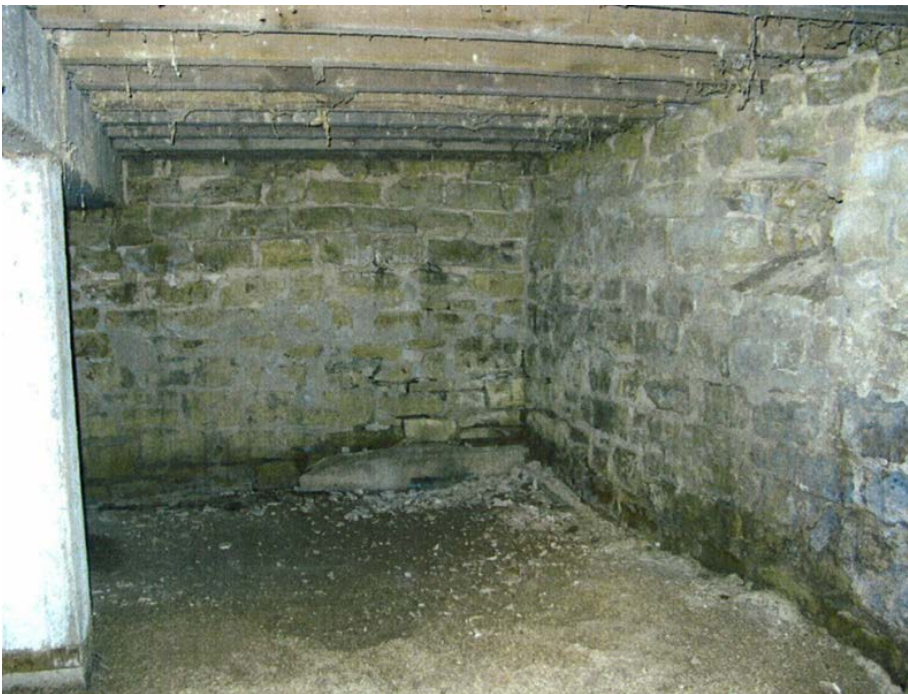
Basement and Foundation – the existing basement is exposed limestone wall with 5-6ft in head clearance, water seepage is exhibited through the foundation. There appears to be a solid compacted or concrete floor. Access is from the exterior scuttle stair; there is no interior stair. The foundation requires removal of non-historic mortar patches, new mortar repair, partial stone inserts and tuck pointing.

Basement crawl space with limestone foundation

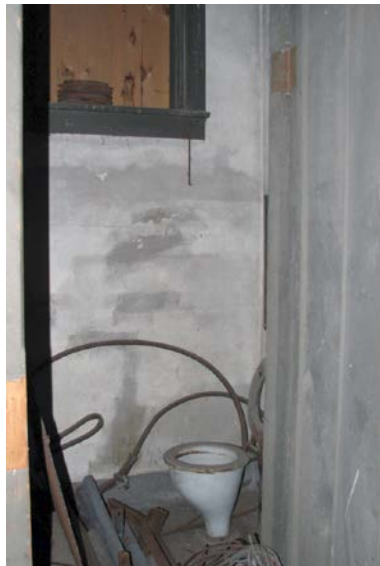
Water Closets – these are non-operational. This area was added to the structure in the 1920's. This addition is non-contributing and should be removed.

Plumbing – two water closets appear to have been added to the original structure sometime after 1919, assuming 1920's due to the poured concrete foundation. Non-operational.

Existing Water Closet

Removal - 1920's Toilet room addition – It is recommended to remove this non-contributing element

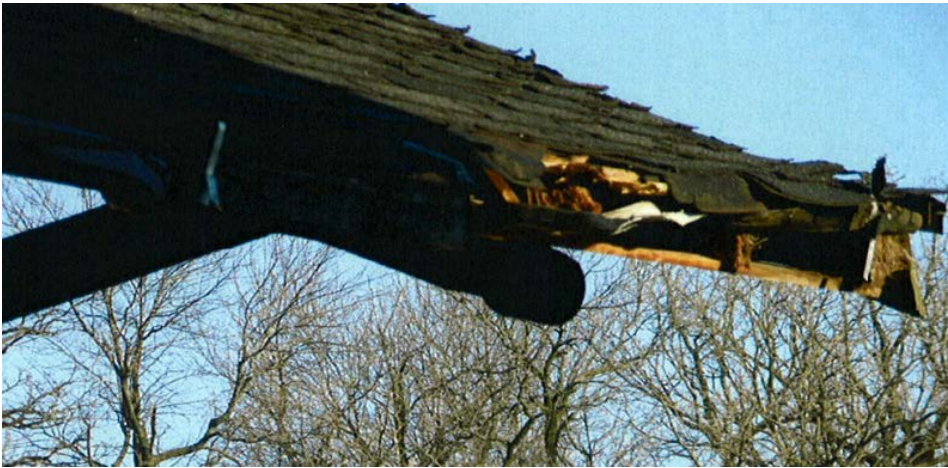
Eaves – The edge condition of the roof system is deteriorated in areas and requires stabilization and selective replacement. Soffits show deterioration and require stabilization and selective replacement. As much as 80% may need replacement. This is caused by water infiltration over the years.

Eaves & Soffits – In disrepair due to water damage and impact damage

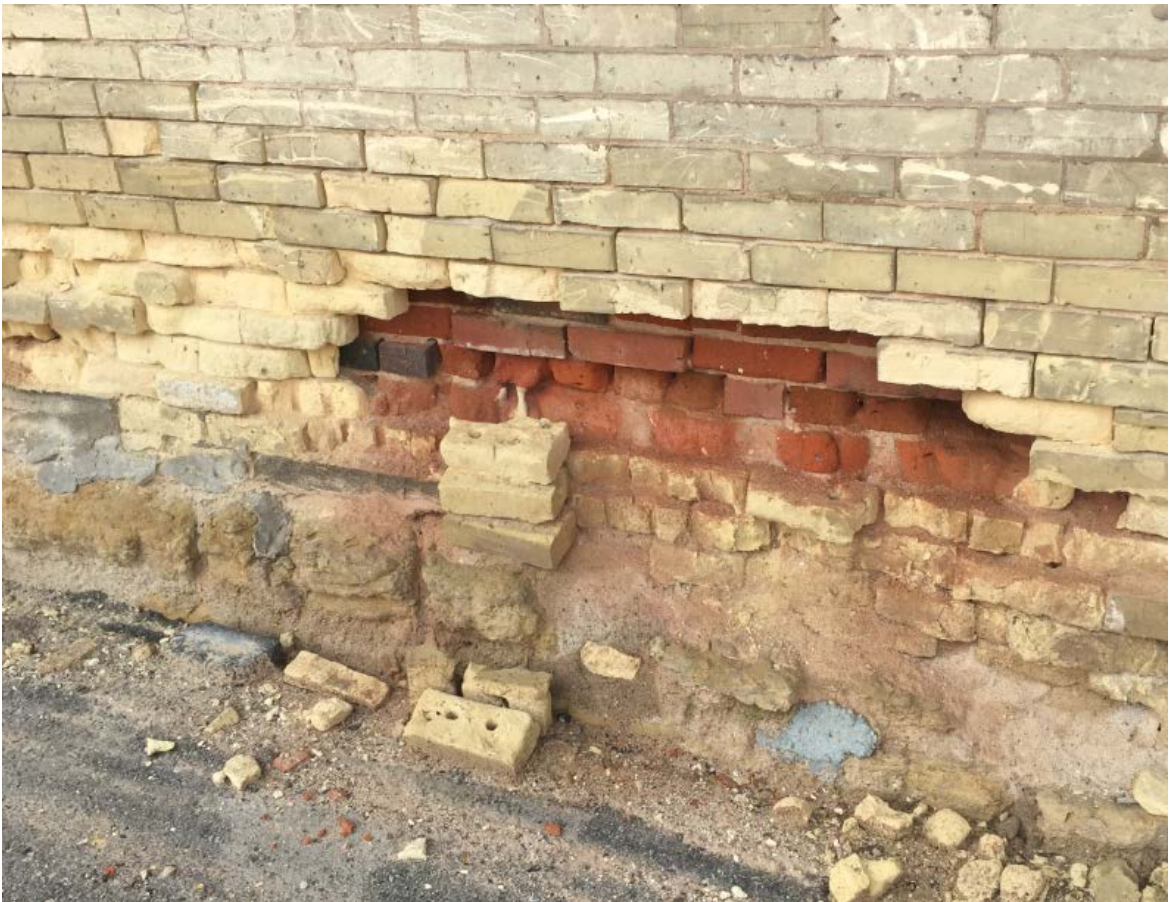
Brick Degradation – Triple Wythe wall is deteriorating from surface water and leaking roof allowing water into wall cavity. Tuck pointing is needed on all facades

Water damage and degraded masonry

Mortar analysis –will be performed in preparation for repair

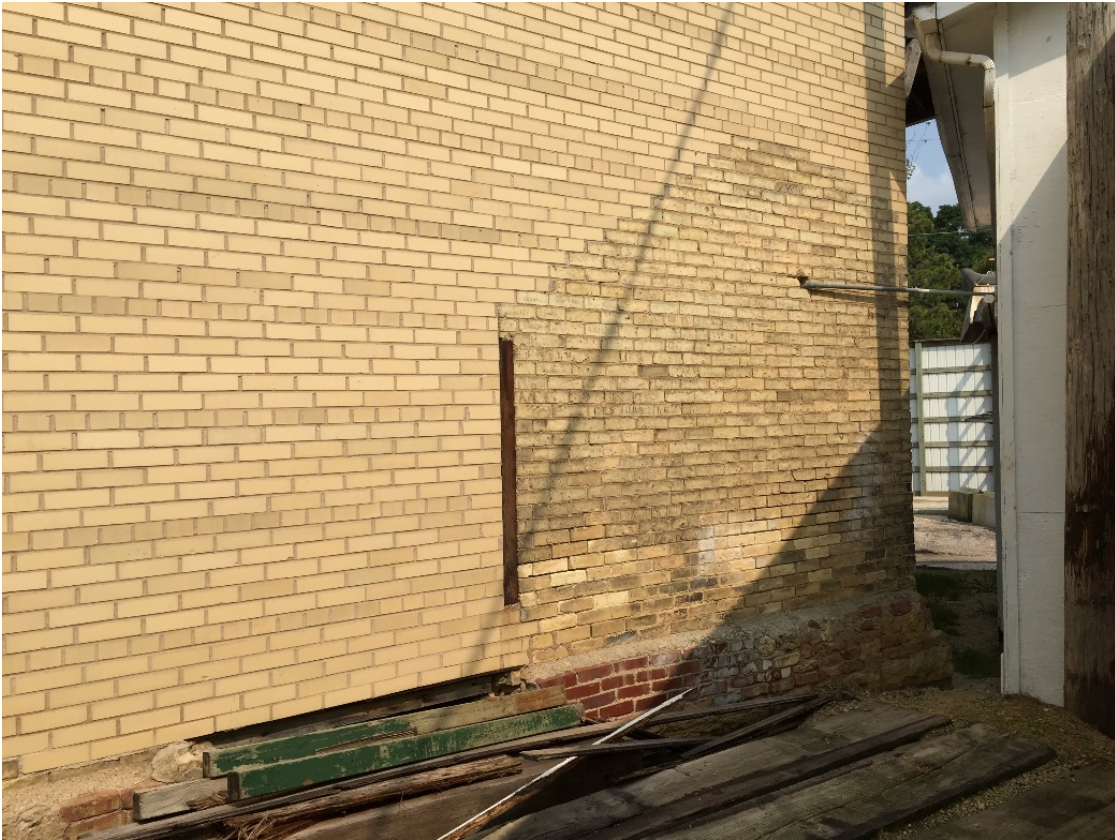
South wall – Non-historic Brick Condition, Exterior

Secondary Facade – the South façade has been repaired in the mid-late 20th Century. It has no window openings and only a 1 ft overhang. Based on this non-historic brick condition, this façade would be an ideal location if an historically sensitive addition is needed for the re-use of the building.

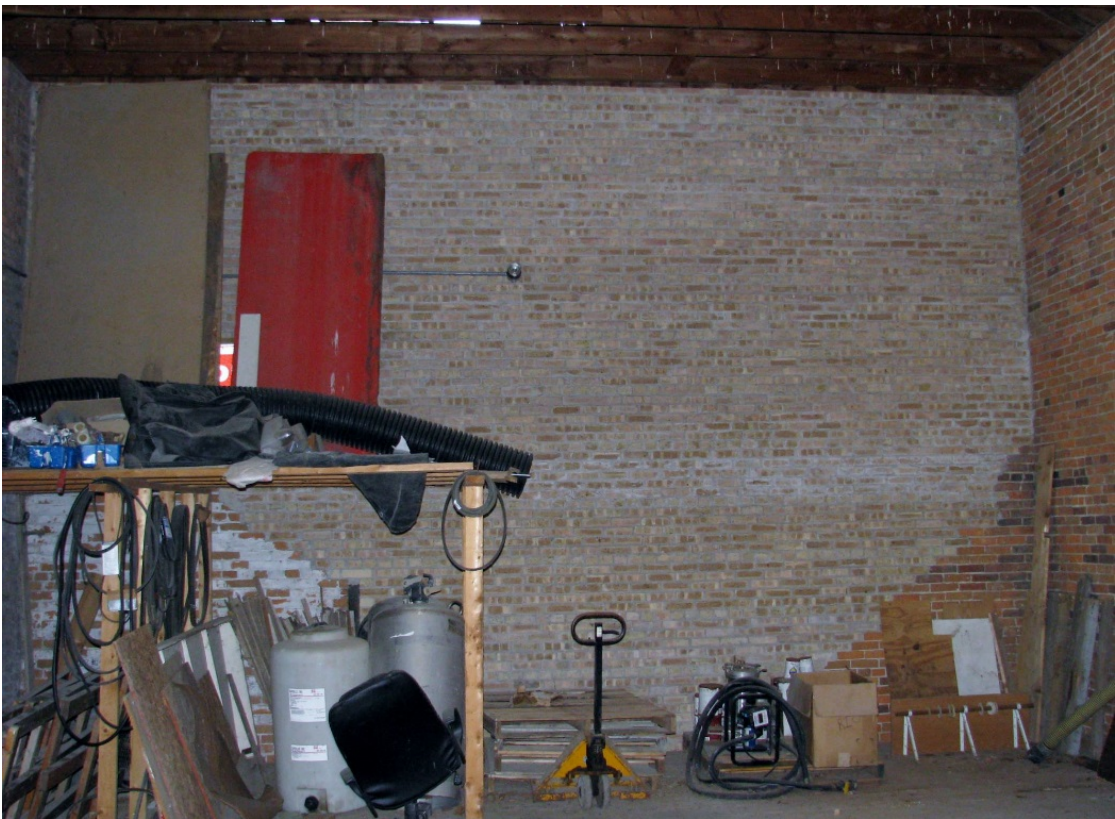
South wall – Non-historic Brick Condition, Interior

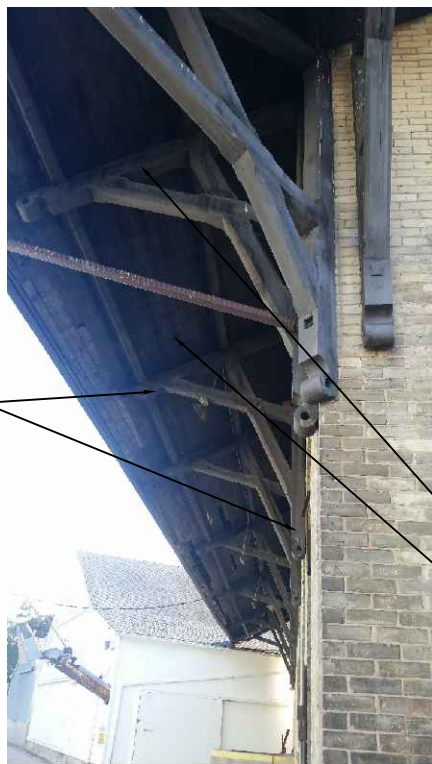
AREA # 2- ROOF OVERHANG CONDITION

ROOF MAINTENANCE HAS BEEN NEGLECTED- LEAKING WATER HAS STARTED TO COMPROMISE THE STRUCTURAL BRACKETS

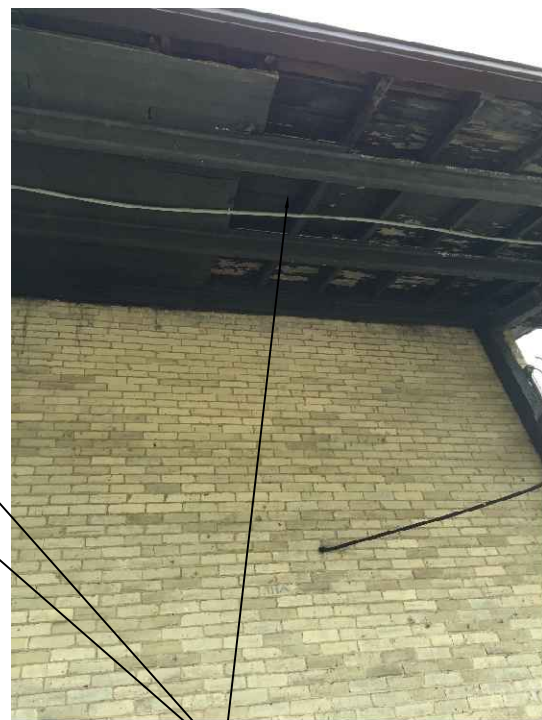
ROOF MAINTENANCE HAS BEEN NEGLECTED- WATER HAS BEEN LEAKING INTO THE SOFFIT AND HAS ROTTED THE EXISTING WOOD BREADBOARD THIS IS A TYPICAL PROBLEM AROUND THE STRUCTURE

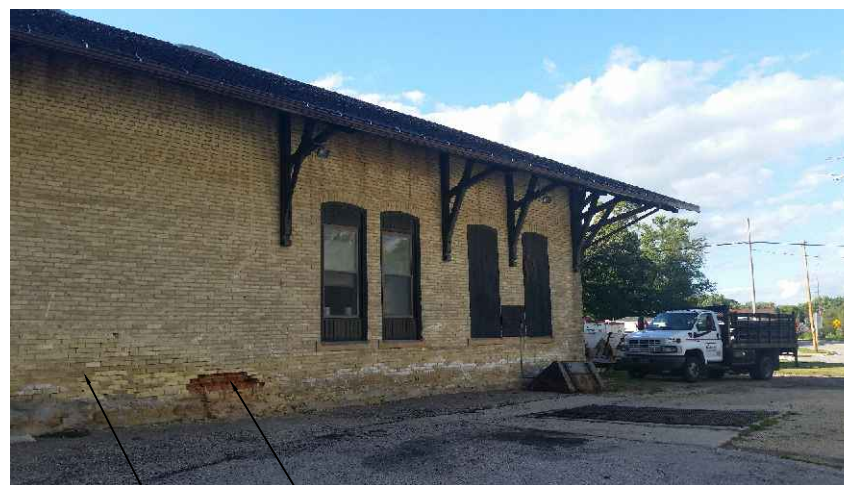
AREA # 1- BRICK / STONE DETERIORATION @ BASE

MAINTENANCE TUCK POINTING WAS NEGLECTED

ROOF WATER SPLASHING OFF BLACKTOP ALONG WITH FREEZE AND THAW CYCLES HAS BROKEN DOWN THE BRICK

ROOF WATER SPLASHING OFF BLACKTOP ALONG WITH FREEZE AND THAW CYCLES HAS DETERIORATED THE BRICK POWDER

ROOF LEAKS ALLOWING WATER TO PENETRATE WALL SYSTEM

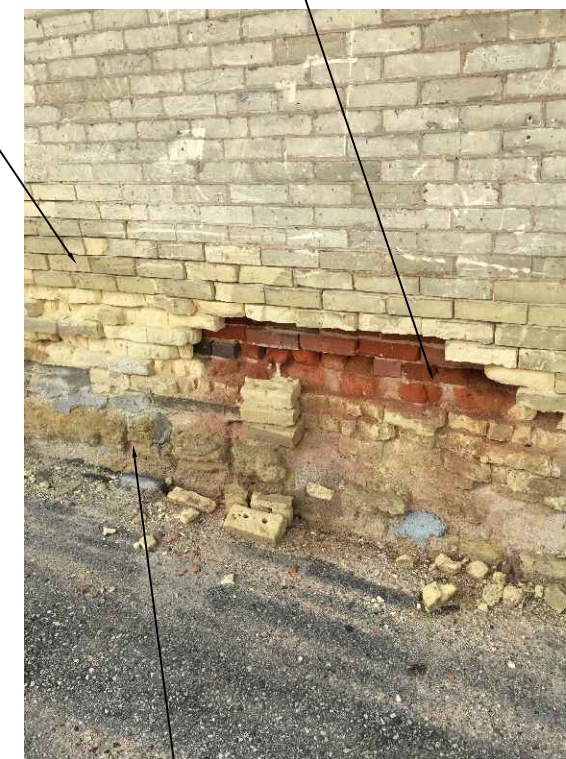
LIMESTONE FOUNDATION SHOWING THE SAME DETERIORATION IN CERTAIN AREAS

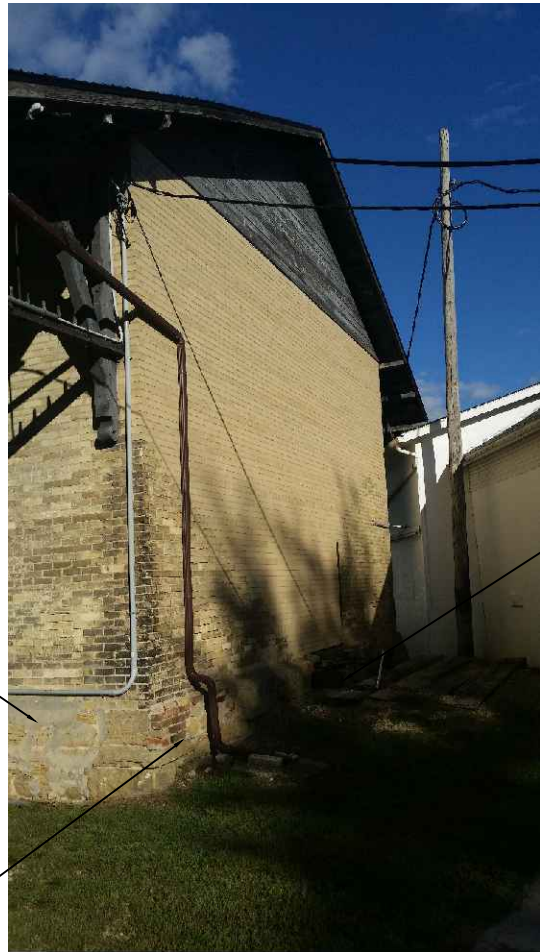
AREA #3

MISCELLANEOUS BRICK USED FOR REPAIRS REPLACE W/ LOCAL LIMESTONE

INCORRECT MORTAR USED FOR REPAIRS

EXISTING CRAWLSPACE ACCESS BURIED WITH RAILROAD TIMBERS

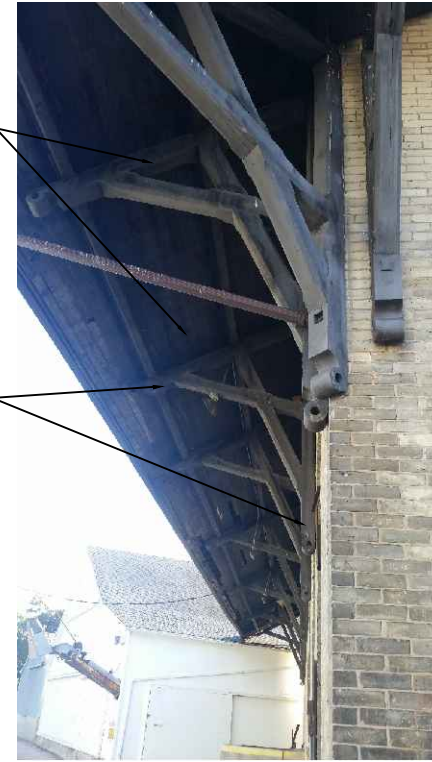
AREA # 2- ROOF OVERHANG CONDITION

ROOF MAINTENANCE HAS BEEN NEGLECTED- WATER HAS BEEN LEAKING INTO THE SOFFIT AND HAS ROTTED THE EXISTING WOOD BREADBOARD THIS IS A TYPICAL PROBLEM AROUND THE STRUCTURE

ROOF MAINTENANCE HAS BEEN NEGLECTED- LEAKING WATER HAS STARTED TO COMPROMISE THE STRUCTURAL BRACKETS

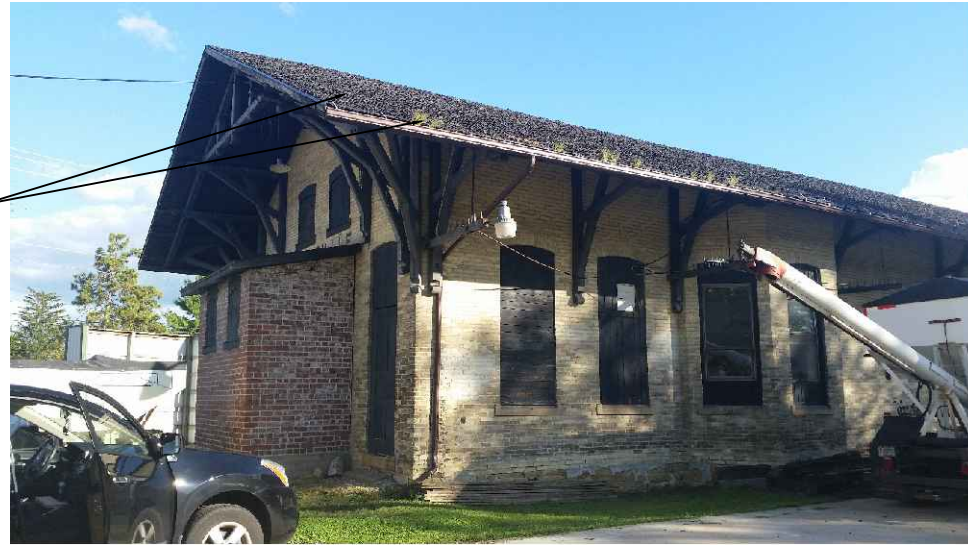
AREA #5

ROOF MAINTENANCE HAS BEEN NEGLECTED- WATER HAS BEEN LEAKING INTO THE SOFFIT AND WALL

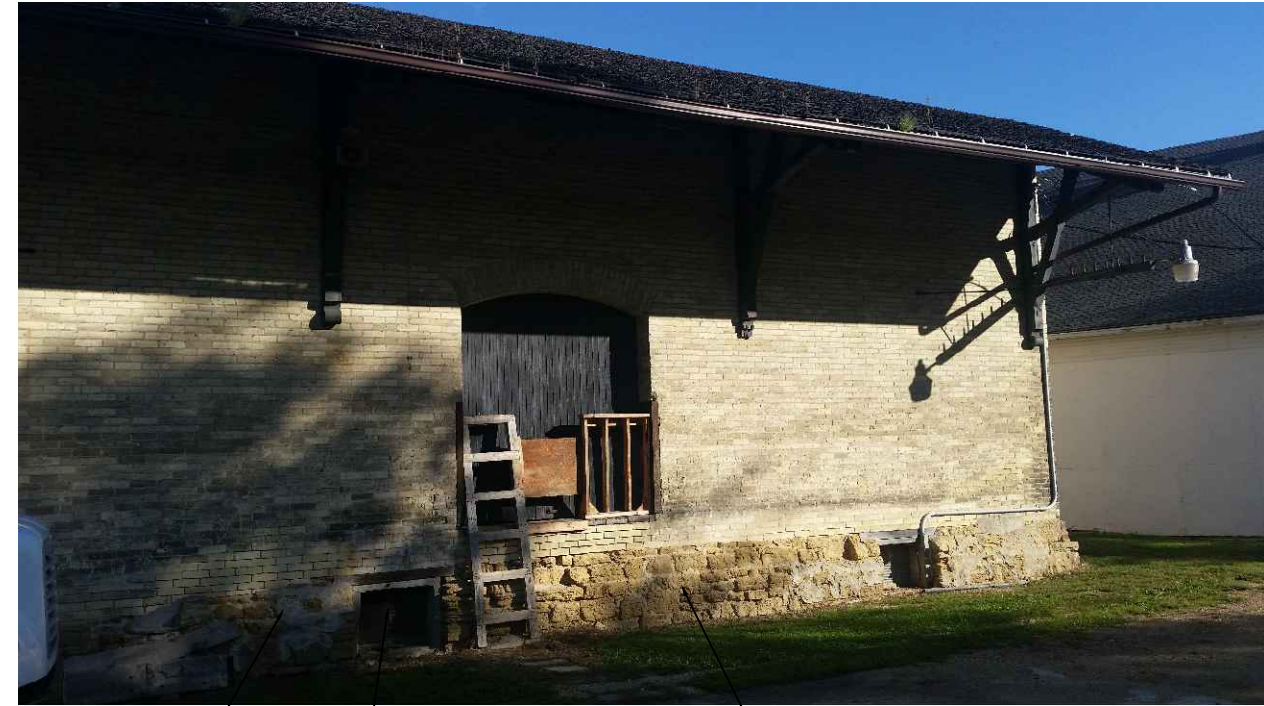
AREA #4

INCORRECT MORTAR USED FOR REPAIRS

EXISTING WINDOW FRAME- NEEDS RESTORATION

STONE FOUNDATION IS NEED OF TUCKPOINTING
