Belleville Train Depot

Historic Structures Report & Study

November 25, 2015

Destree Design Architects, Inc.

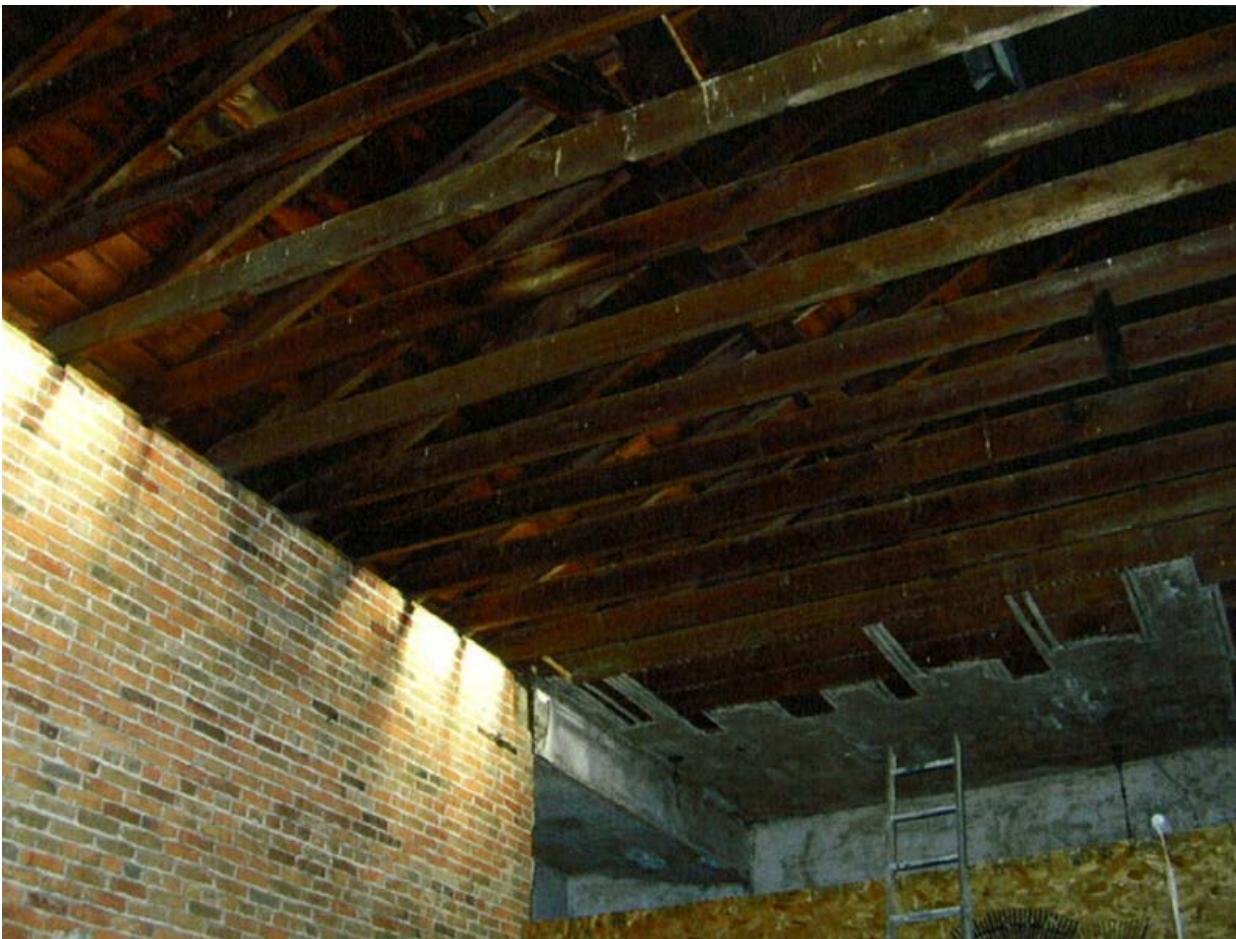
Brackets – The 5-1/2" x 5-1/2" wood brackets are inconsistently spaced around the structure, fastened to the masonry walls with bolt connections. These brackets support 3x6 wood purlins, 2x6 purlins and wood 1x4 tongue and groove planking. The 2x6 rafters span into the interior top chord to create overhang. An estimate of three 93) brackets may need to be recreated. This is a premier contributing historic feature.

Eaves – The edge condition of the roof system is deteriorated in areas and requires stabilization and selective replacement. Soffits show deterioration and require stabilization and selective replacement. As much as 80% may need replacement. This is caused by water infiltration over the years.

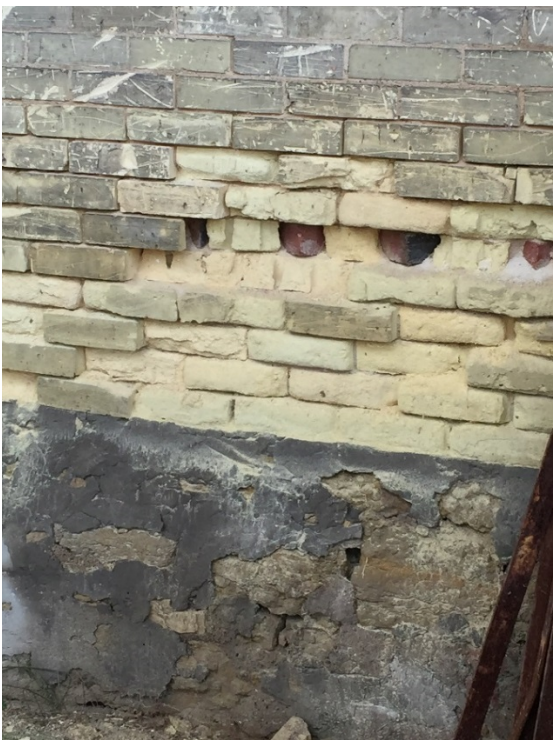
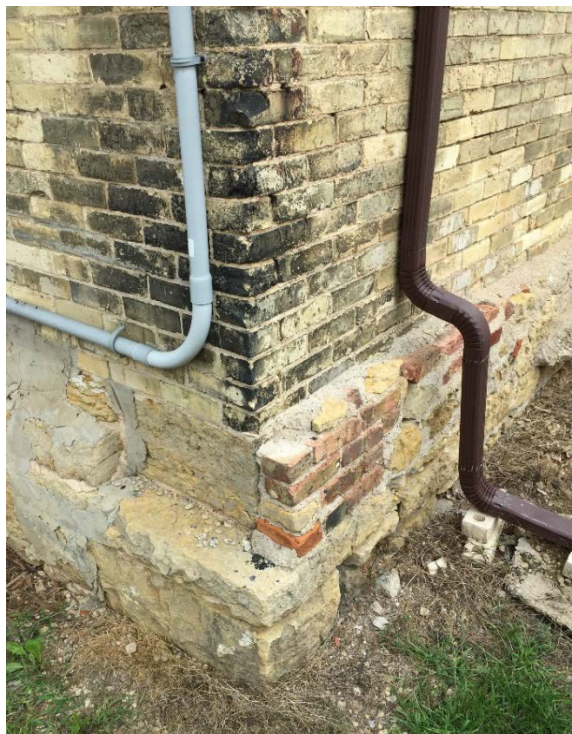
Water damage and degraded masonry

Mortar analysis –will be performed in preparation for repair

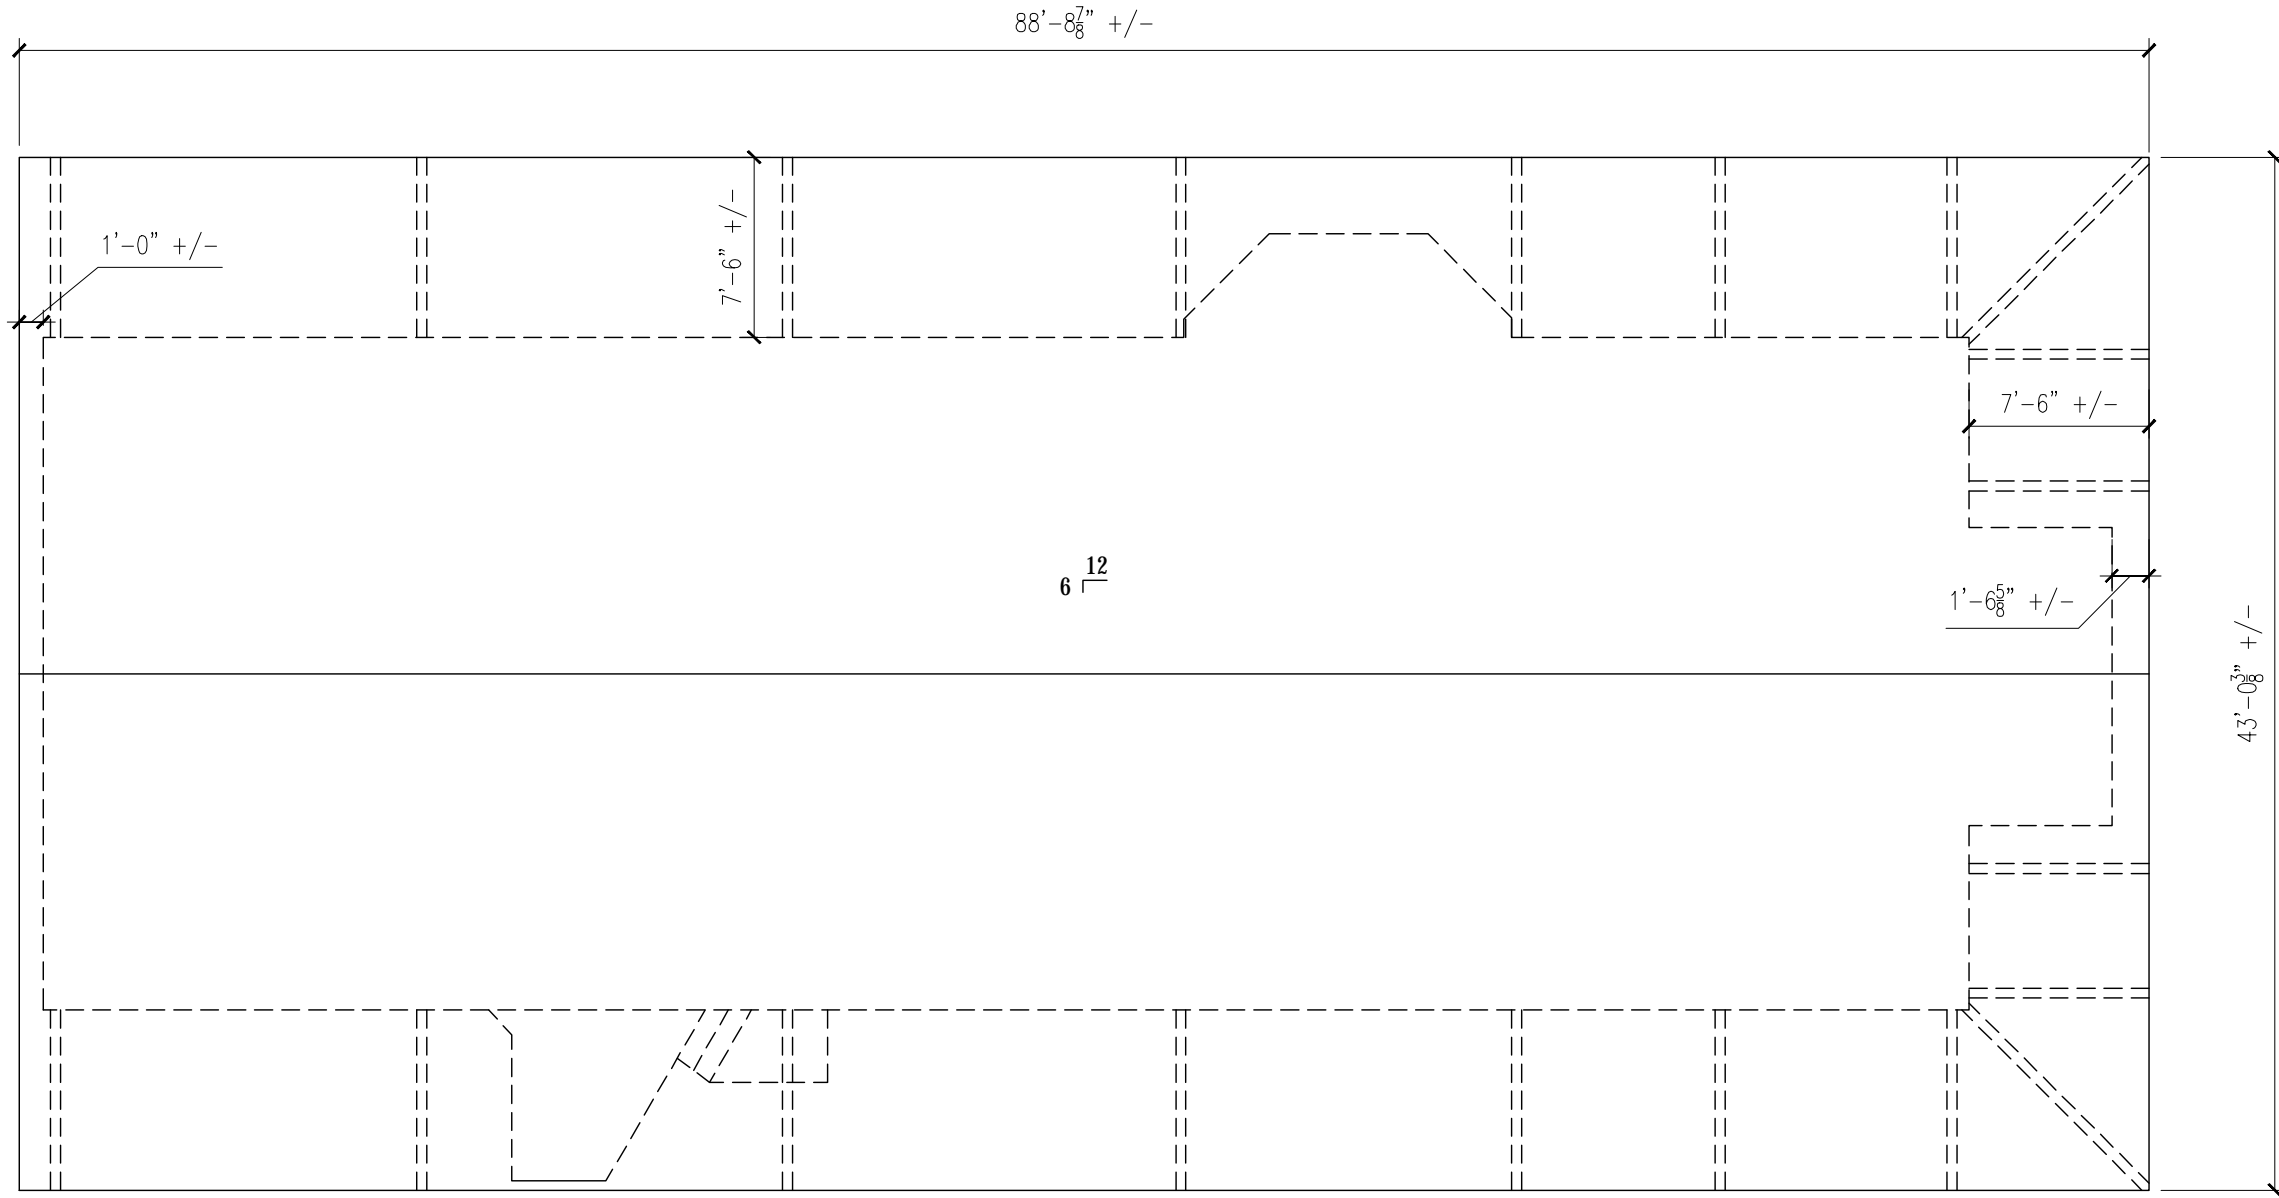
1 ROOF PLAN
 1/8" = 1'-0"

ROOF MAINTENANCE HAS BEEN NEGLECTED- LEAKING WATER HAS STARTED TO COMPROMISE THE STRUCTURAL BRACKETS

AREA # 2- ROOF OVERHANG CONDITION

ROOF MAINTENANCE HAS BEEN NEGLECTED- WATER HAS BEEN LEAKING INTO THE SOFFIT AND HAS ROTTED THE EXISTING WOOD BREADBOARD THIS IS A TYPICAL PROBLEM AROUND THE STRUCTURE

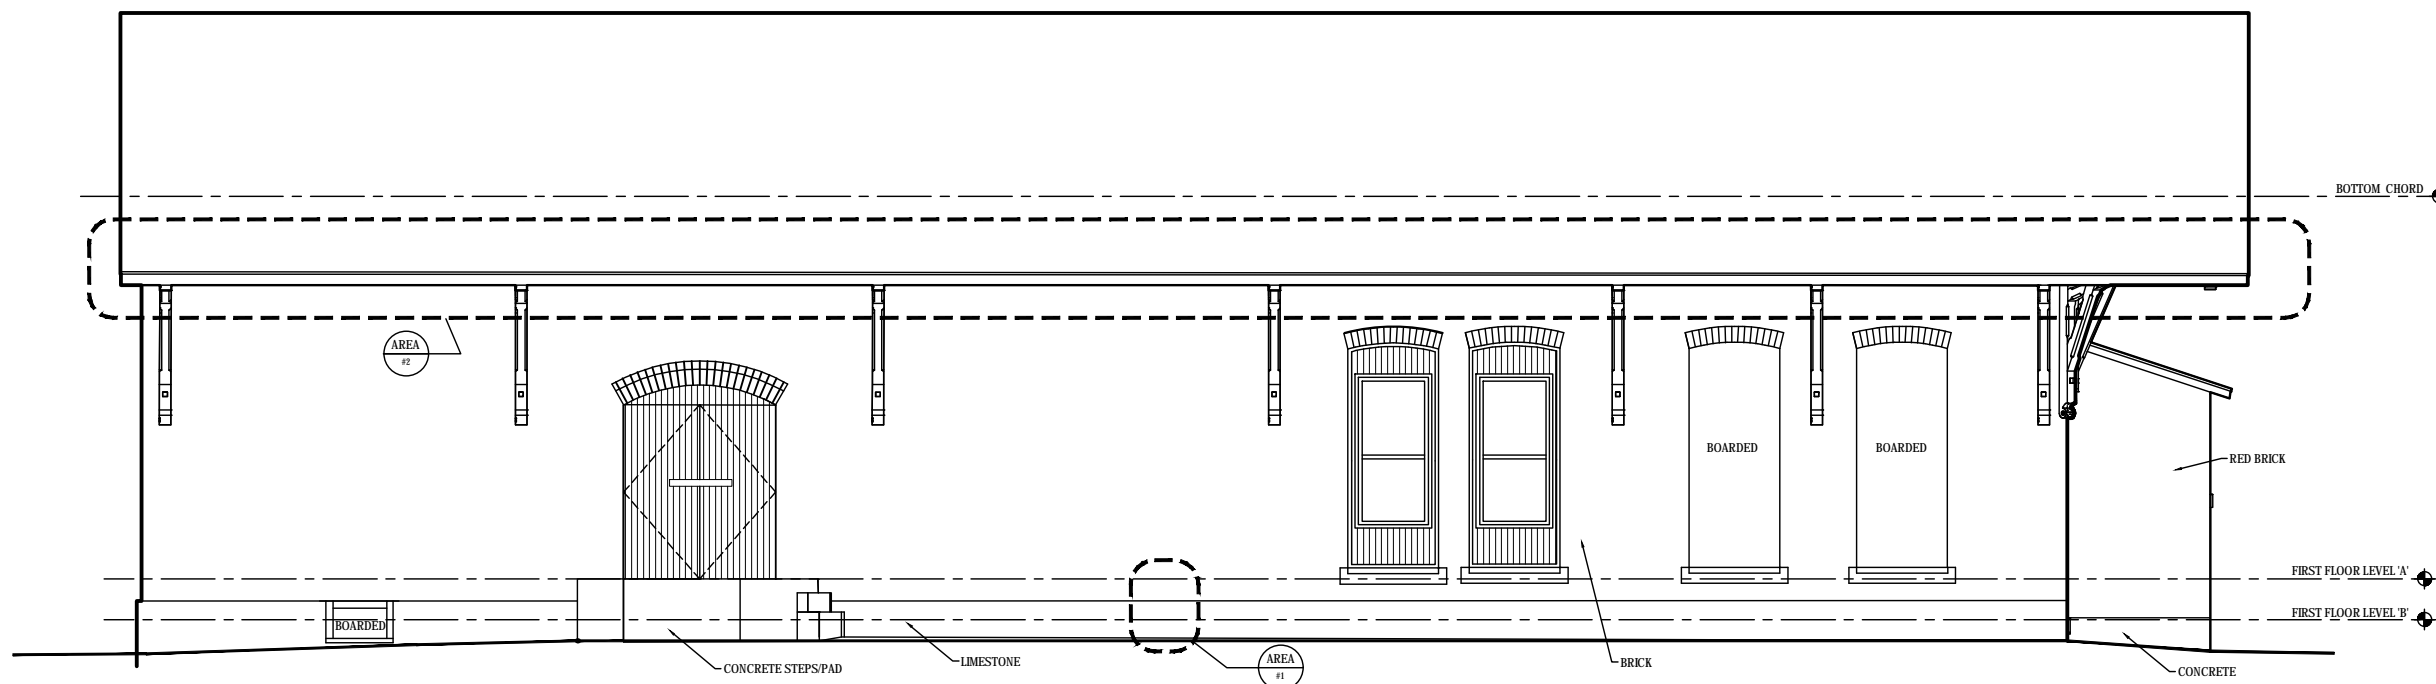
1 EXISTING SIDE ELEVATION
1/8" = 1'-0"

MISCELLANEOUS BRICK USED FOR REPAIRS REPLACE W/ LOCAL LIMESTONE

INCORRECT MORTAR USED FOR REPAIRS

EXISTING CRAWLSPACE ACCESS BURIED WITH RAILROAD TIMBERS

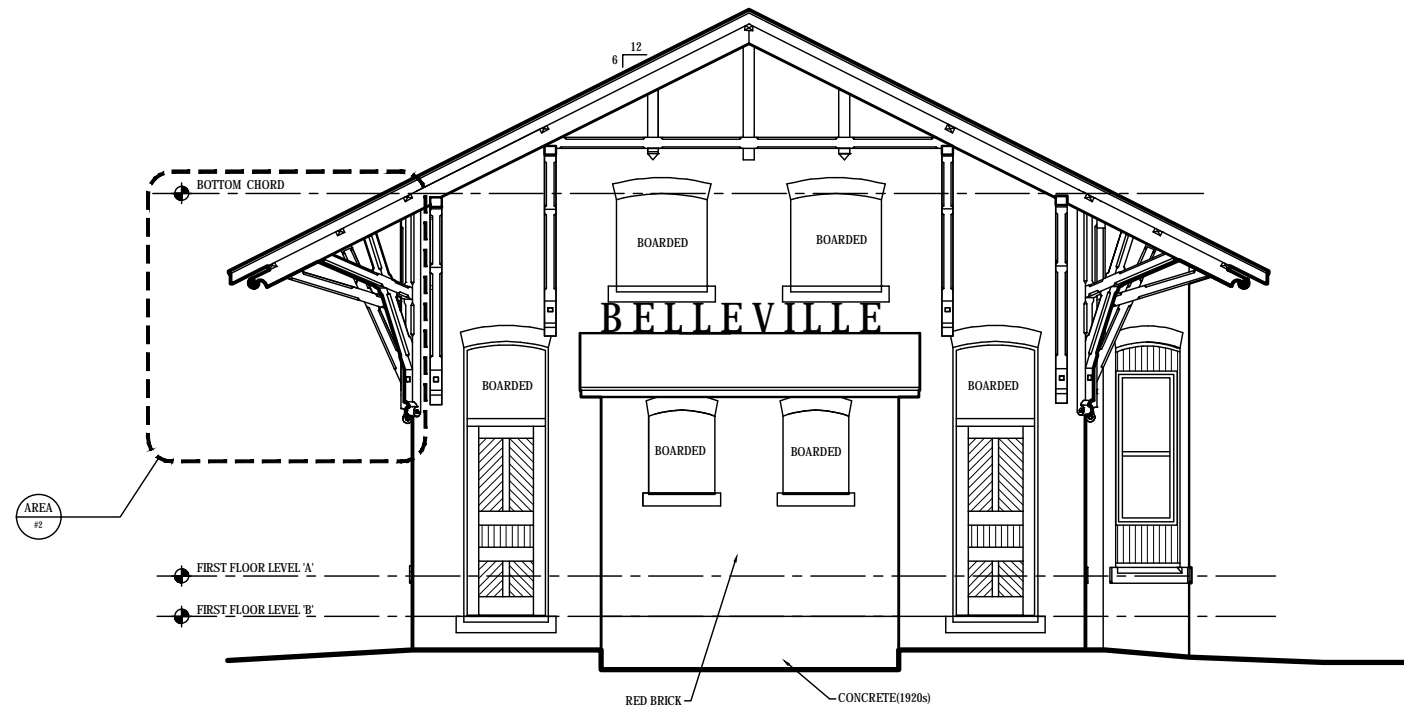
1 EXISTING FRONT ELEVATION
1/8" = 1'-0"

ROOF MAINTENANCE HAS BEEN NEGLECTED- WATER HAS BEEN LEAKING INTO THE SOFFIT AND HAS ROTTED THE EXISTING WOOD BREADBOARD THIS IS A TYPICAL PROBLEM AROUND THE STRUCTURE

ROOF MAINTENANCE HAS BEEN NEGLECTED- LEAKING WATER HAS STARTED TO COMPROMISE THE STRUCTURAL BRACKETS

AREA # 2- ROOF OVERHANG CONDITION

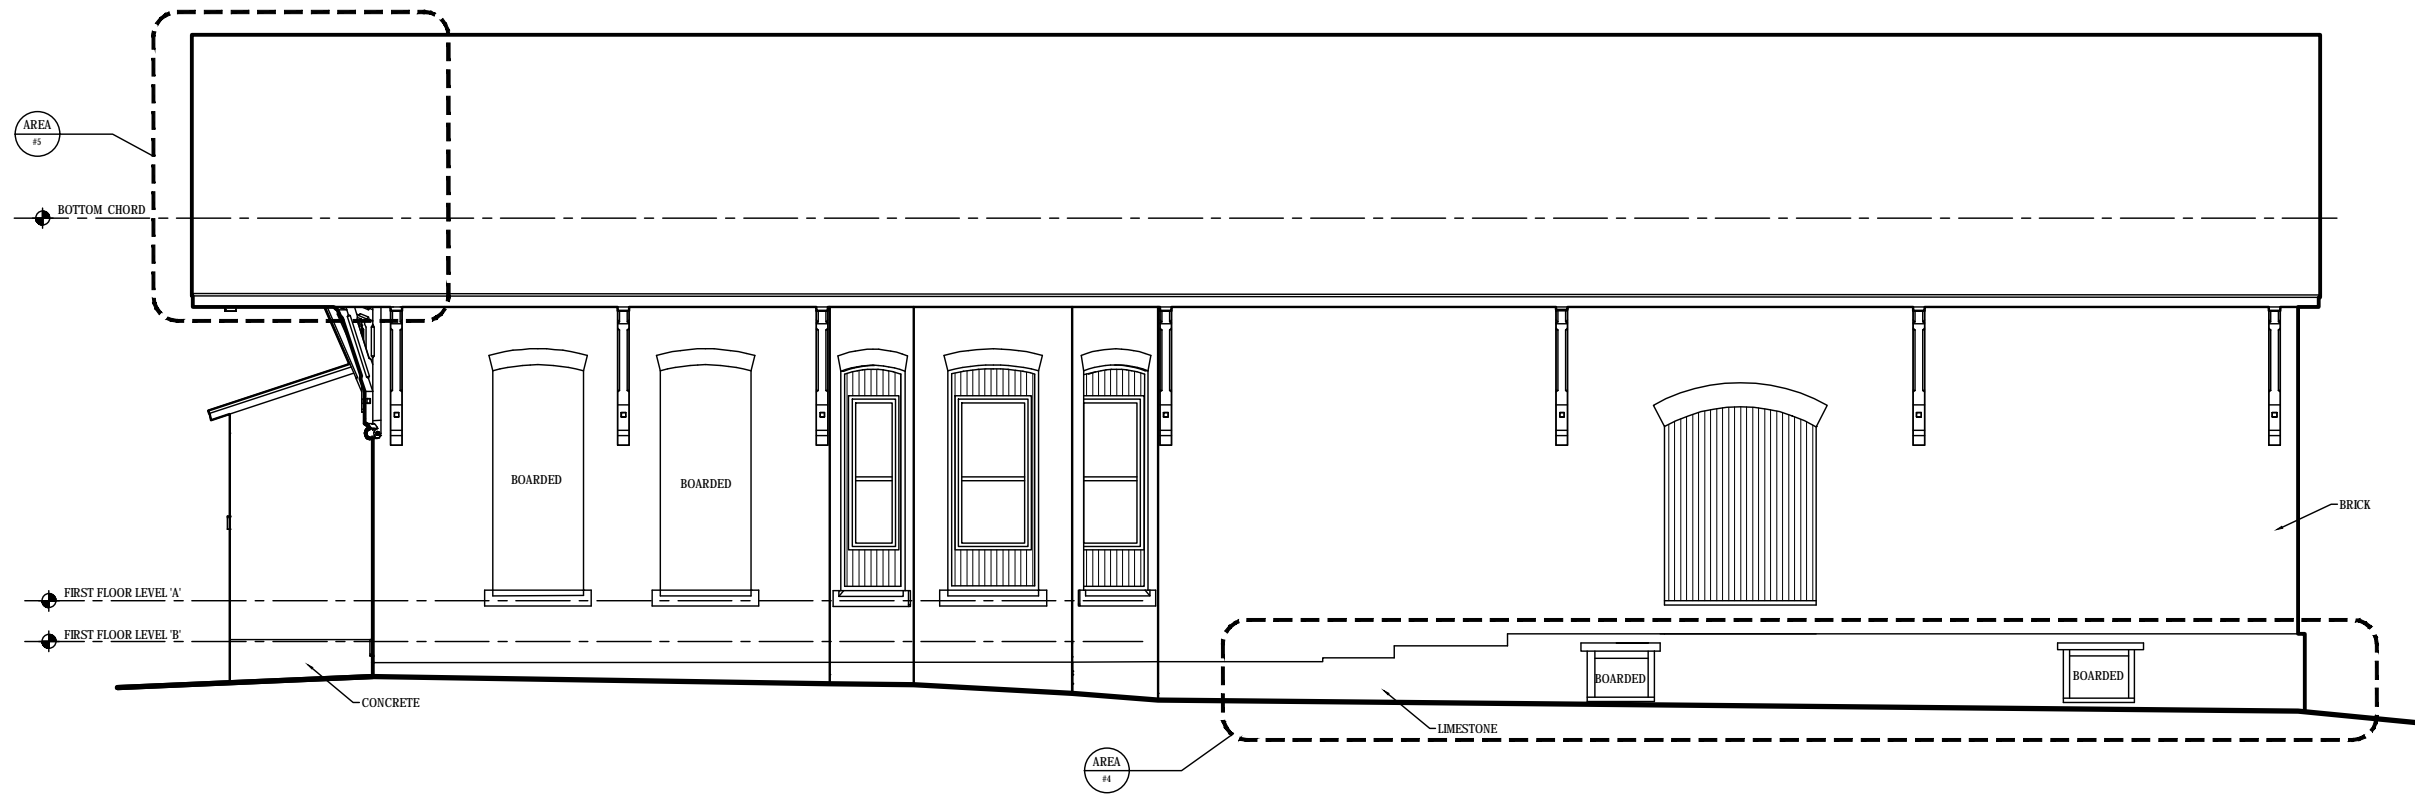
1 EXISTING SIDE ELEVATION
1/8" = 1'-0"

ROOF MAINTENANCE HAS BEEN NEGLECTED- WATER HAS BEEN LEAKING INTO THE SOFFIT AND WALL

INCORRECT MORTAR USED FOR REPAIRS

STONE FOUNDATION IS NEED OF TUCKPOINTING
